Rupture of a DOT-105 Rail Tank Car and Subsequent
Chlorine Release at Axiall Corporation
New Martinsville, West Virginia
August 27, 2016

Accident Report

NTSB/HZM-19/01
PB2019-100294

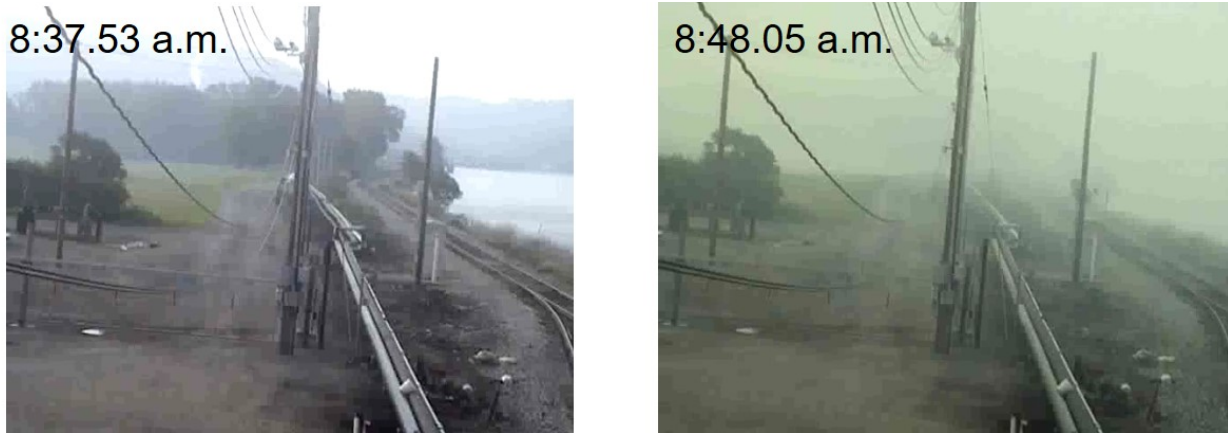
Figure 3. Axiall security camera views, August 27, 2016. (Photographs courtesy of Axiall.)

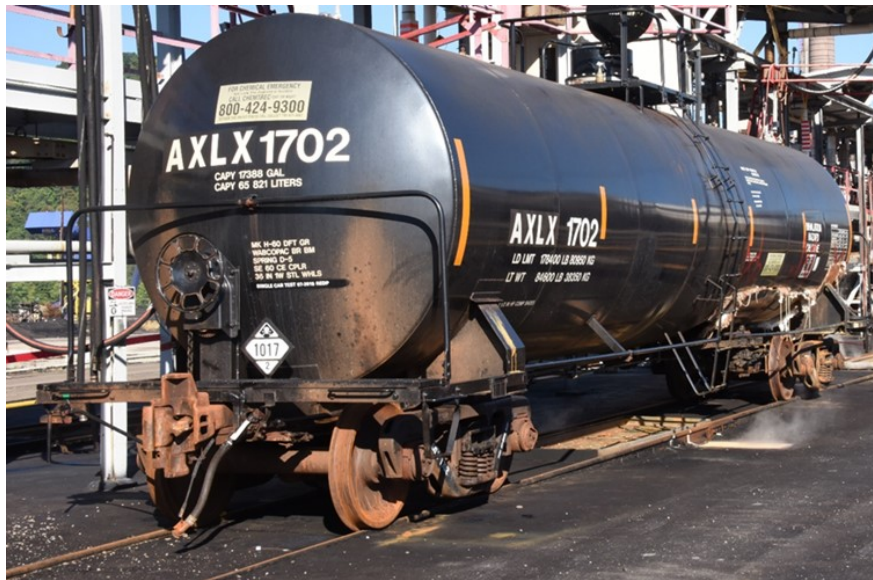
Figure 4. Tank Car AXLX1702, postincident. (Photograph courtesy of Axiial.)

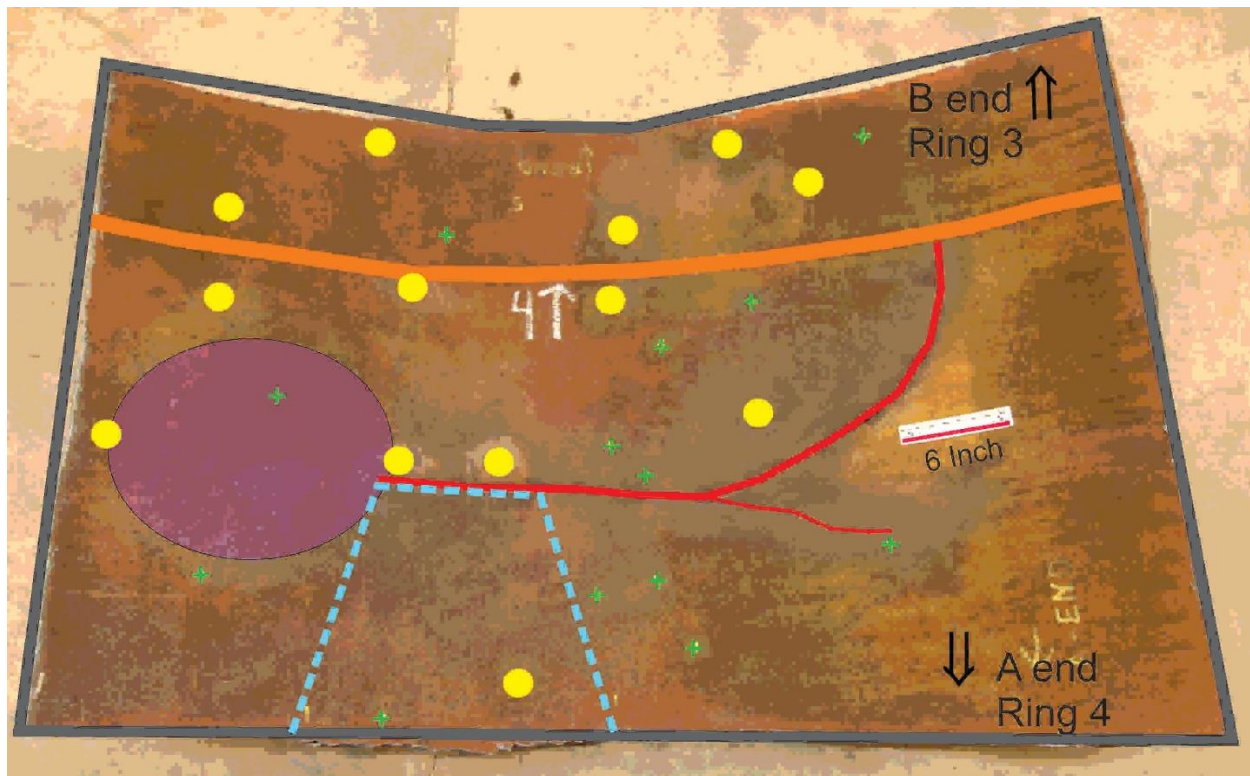
surface (dashed blue line), and girth weld between tank ring 3 and tank ring 4 (orange line).³⁴ The purple oval on the left of the cradle pad indicates the area with visible interior surface scaling. Ground spots are identified with a green + mark.

The shell material in tank ring 4 buckled between the crack at the cradle pad plate and the tank ring 3 to 4 girth weld joint. Over this 11-inch distance, the interior surface was deformed downward about 1/2 inch. The circumferential extent of the deformation could not be measured because of the size of the sample.

Figure 9. Annotated view of the interior side of the tank shell coupon.

An area of surface oxidization (scale) that measured 0.03-inch thick was found on the interior tank surface near the right corner of the cradle pad. The scaling boundaries were indistinct, but the area was estimated to be at least 12 inches in diameter and included the right-side termination of the crack. Shell thickness measurements within the scaled area with the scale removed were below the minimum allowed.³⁵ A metallographic section from the scaled area also showed decarburization 0.006-inch deep and scaling on both the interior and exterior surfaces. The scaled area material surface hardness measured somewhat softer than the
