Rupture of a DOT-105 Rail Tank Car and Subsequent
Chlorine Release at Axiall Corporation
New Martinsville, West Virginia
August 27, 2016

Accident Report

NTSB/HZM-19/01
PB2019-100294

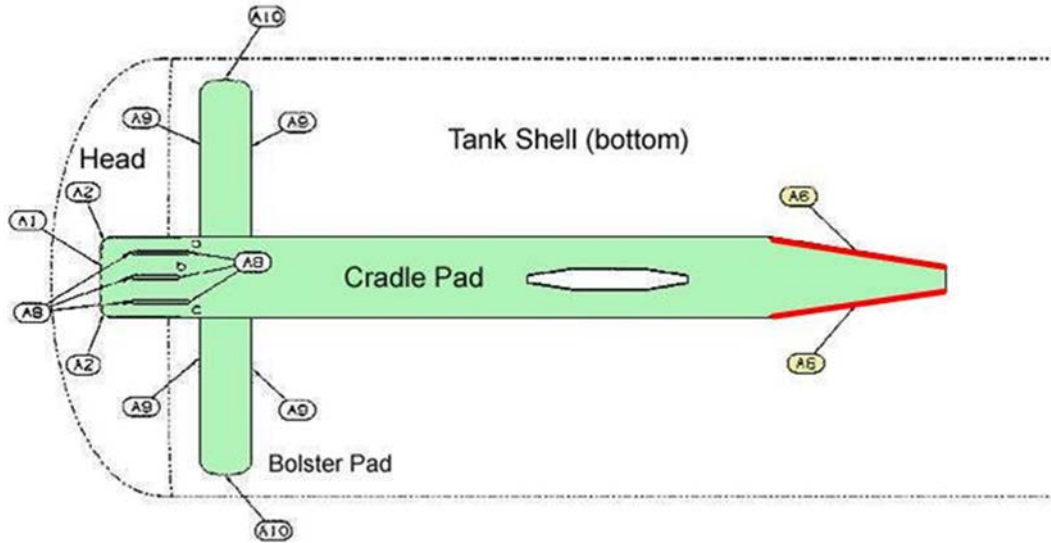
The ACF-200 stub sill underframe of the tank car was originally manufactured by ACF Industries, Incorporated. Figure 5 shows the ACF-200 underframe layout with cradle pad and bolster components and weld identification numbers from the AAR Data Collection template. At the inboard end of the cradle pad, A6 designates fillet welds.¹⁵ Figure 6 provides a three-dimensional view of the tank car and underframe showing the cradle pad and inboard fillet weld and terminations and attached underframe components.

Figure 5. ACF-200 underframe general layout and weld identification numbers.

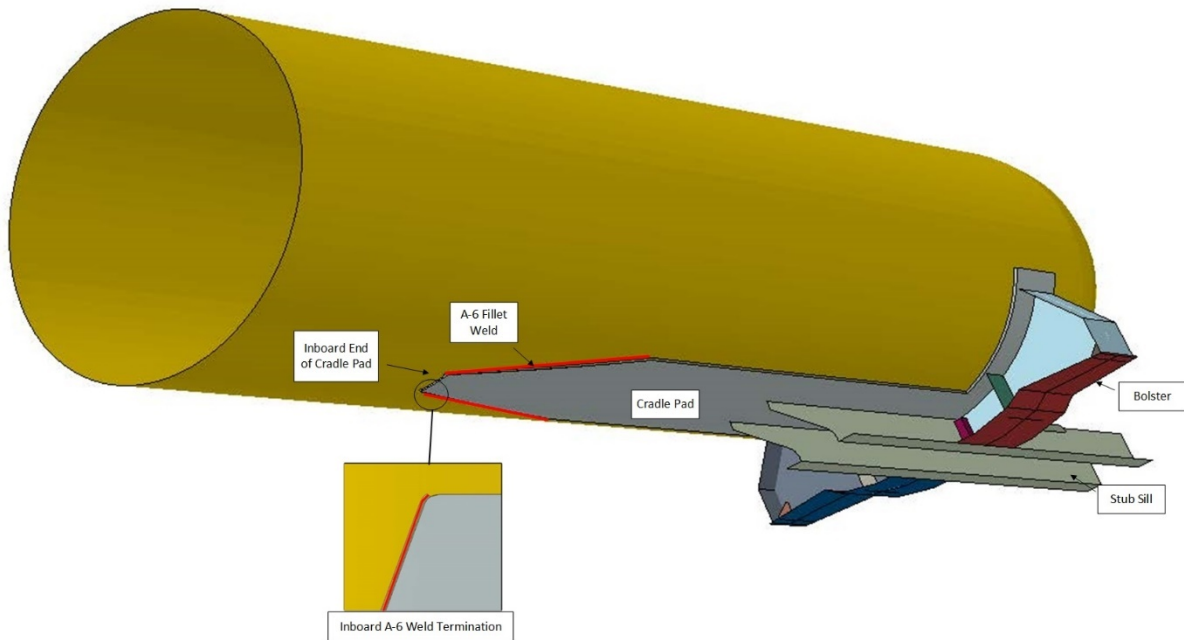
While both general service and pressure tank cars have employed the ACF-200 stub sill underframe design, about 2,186 DOT-105 pressure tank cars were equipped with this underframe.¹⁶ The design used cradle pads welded to the tank to transfer running loads from the stub sills through the tank.¹⁷ The ACF-200 underframe layout position of the cradle pad and bolster pad is shown in figure 5. The pads are highlighted in green and fillet welds designated A6 at the inboard end of the cradle pad are highlighted in red.

Figure 6. Three-dimensional image of the tank car and underframe.
